# The Air in There

## *Enhancing an Indoor Pool Environment*

**Parker Recreation Center, Parker, Colo.**

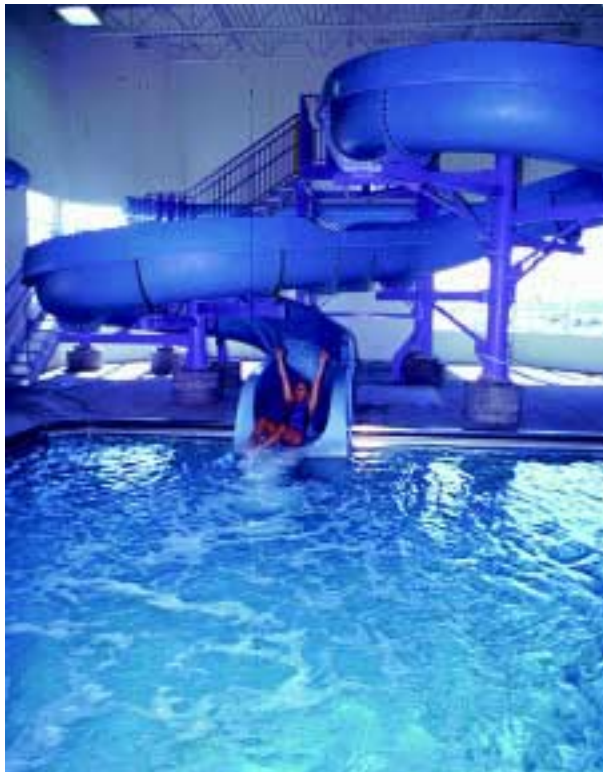
*The facility's 25-meter, 188,000-gallon main pool features a unique zero-depth entry section. An adjacent 14,000-gallon splash pool, with sliding board, is also popular with the center's younger members. During the center's busy season, bather loads can easily run from 500 to 800 daily, and the pools are open every day from 5:30 a.m. to 9:30 p.m.*

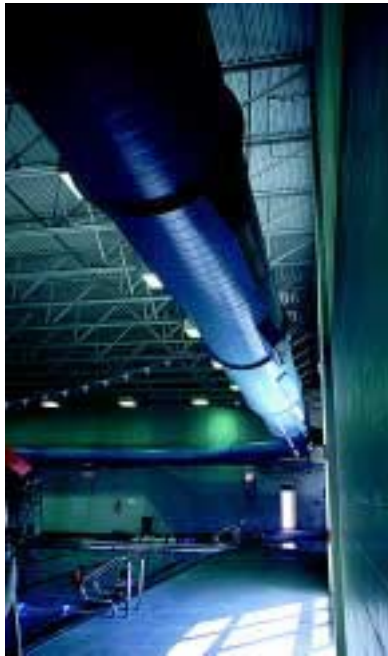
At the same time, the indoor pool facility's total air handling system showed marked deterioration due to the presence of high chloramine levels in the air. Even the facility's dehumidification system condensate was displaying high levels of combined chlorine (0.6 to 0.8 ppm). Only a year and a half after startup, the fans and coils on the ventilation and heating system showed visual signs of corrosion, and a bearing had blown on one of the main fans.

*The indoor pool facility's total air handling system showed marked deterioration due to the presence of high chloramine levels in the air. Even the facility's dehumidification system condensate was displaying high levels of combined chlorine (0.6 to 0.8 ppm). Only a year and a half after startup, the fans and coils on the ventilation and heating system showed visual signs of rust and a bearing had blown on one of the main fans.*

Frustrated, the center's managers were preparing to invest in larger air-handling equipment when a possible solution was brought to management's attention. On the advice of the pool's contractor, the center decided to try a new process control system, which is designed to provide precise control for pool water chemistry and air quality in indoor aquatic facilities. A Stranrol Environmental Control System (ECS), manufactured by USFilter's Stranco Products in Bradley, Ill., was installed at Parker Recreation Center in November 1998.

With the ECS, combined chlorine levels in the dehumidification system's condensate are undetectable. This translates into prolonged equipment life and less maintenance caused by breakdowns and corrosion of pool and facility hardware. Additionally, the new system

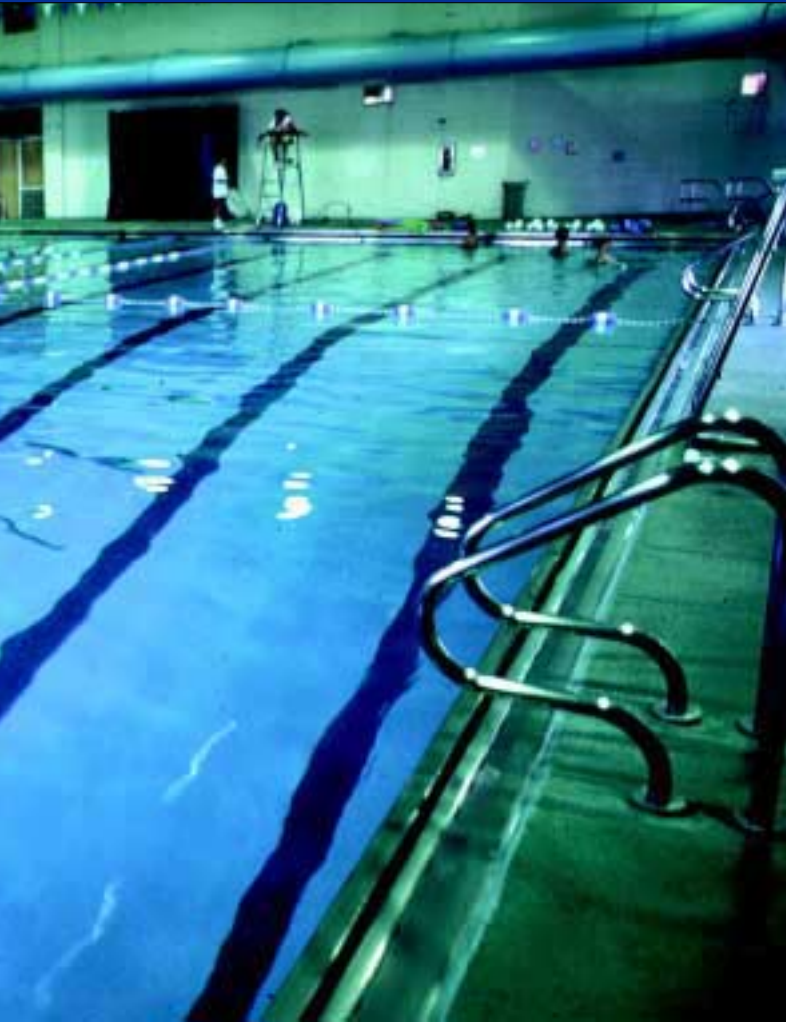
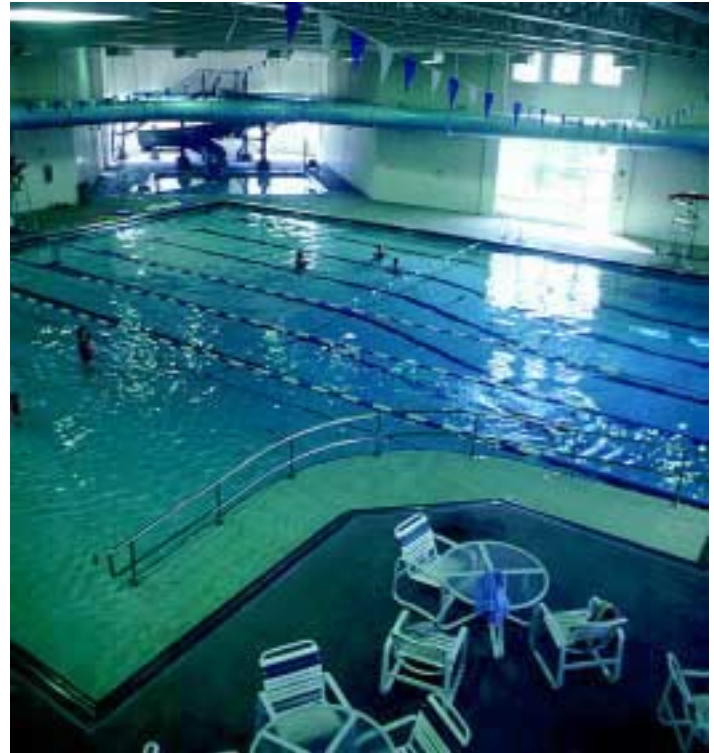
*During a four-year period, guests of Parker Recreation Center consistently complained of skin irritation and eye burn. Patrons also attributed sinus and bronchial infections to swimming in the pool. As a result of complaints, center management spent a lot of time sending pool water out for laboratory testing and filling out Health Department reports. In addition, the center had the Health Department come to the facility on a regular basis to verify that the pool water was safe to swim in.*
